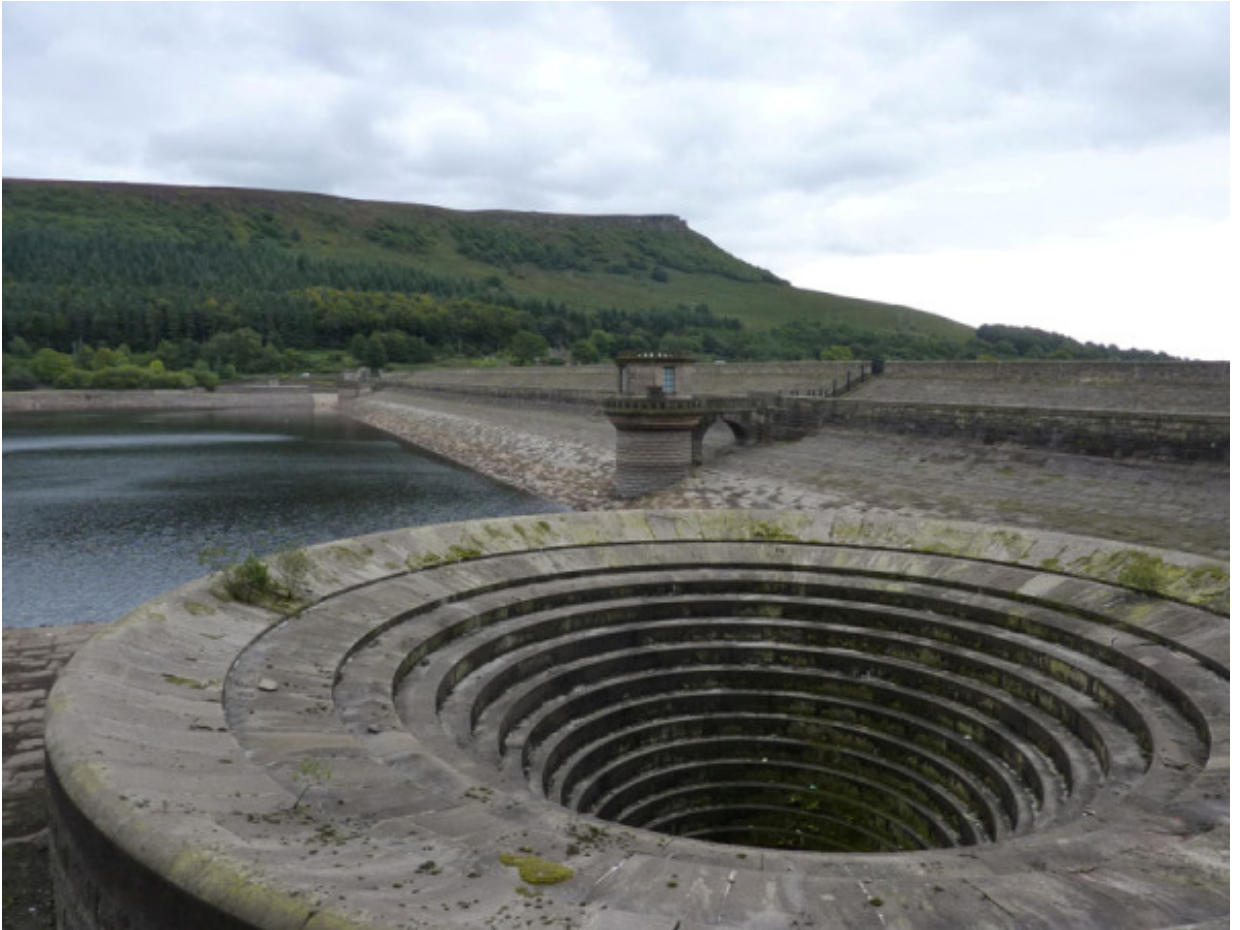
This is one of two overflows next to the dam of the Ladybower Reservoir in the Peak District, Derbyshire. The design is that of an inverted bell so that water can enter all around the perimeter, and hence they are called bellmouth overflows (locally named the 'plugholes'). Each overflow discharges via its own valve house at the base of the dam. The bellmouths are often completely out of the water and are only rarely submerged, often after heavy rainfall or flooding.
